Subject: Retaining Distinctive Corridor Features

June 2005, ITS Number 31

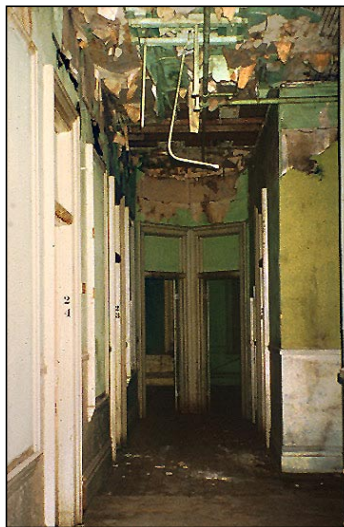
Left: Before the rehabilitation, the historic office building was in poor condition and many of the historic transoms had been sealed. (Before and after views are of different areas).

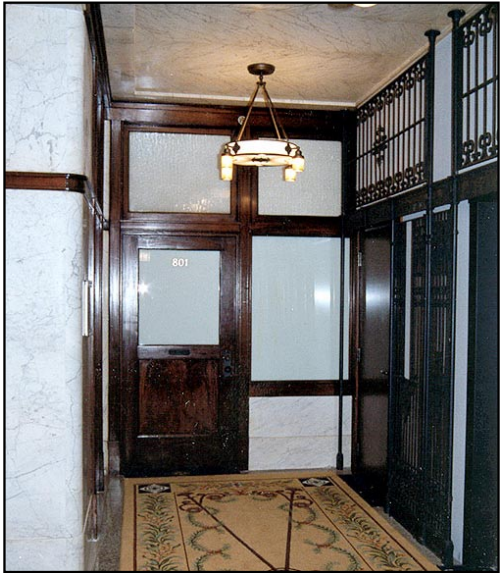
The historic corridors in this office building had reflective surfaces that were character-defining, including glazing, marble wainscoting, and high-gloss varnish on the mahogany trim.

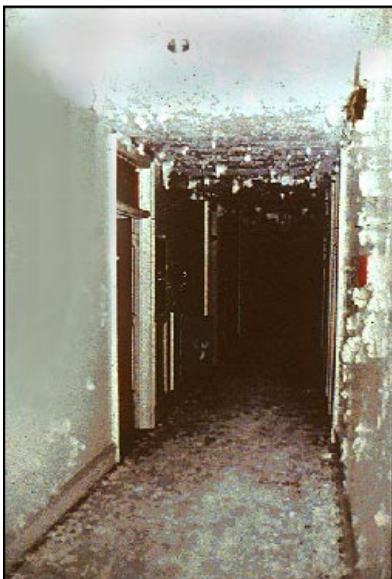
Left: The previous owner had blocked the transoms in this hotel with plywood – a treatment that did not meet the fire rating requirements. The building had been vacant for some time and the finishes were in poor condition.
